Manhole Inspection Summary

Manhole # S25C__049MH

Location Address: **MULBERRY ST** Cross Street: **CARROLLTON AVE**

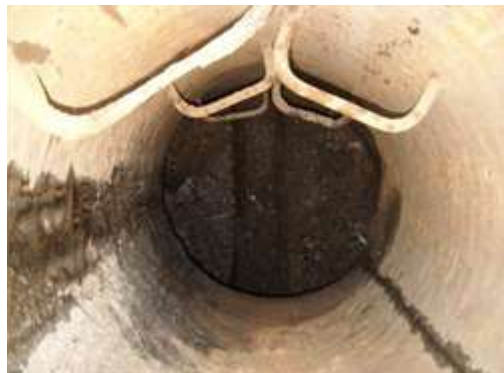
Top View

COULD NOT GET TOP VIEW PHOTO
SHOWING PIPE CONNECTIONS DUE
TO CHANNEL JUNCTION OFFSET

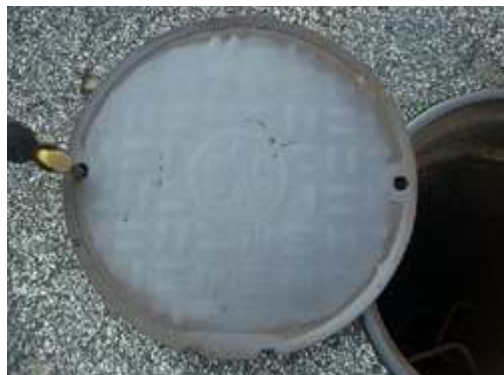
Cover Shape: **Circular** Diameter: **24** (in.) Length: (in.) Dist A/B Grade: **0** (in.)
Type: **Sanitary** Condition: **Worn** Cover Material: **Cast Iron**
Properties: ☐ Bolted ☐ Vented ☐ Water Tight ☐ Water Tight Insert

worn cover

WORN COVER

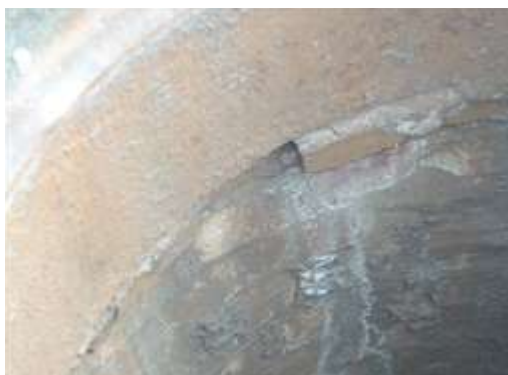
Defect 4

Corbel Material: **Brick** ☐ Parged Type: **Concentric/Eccentric**
Condition: ☐ Sound ☐ Cracked ☐ Root Intrusion ☒ **Loose Brick** ☐ Deteriorated
Infiltration: ☐ None ☐ Joint ☐ Cracks ☐ Mortar ☐ Roots ☒ **Wall**

LOOSE CORBEL BRICKS

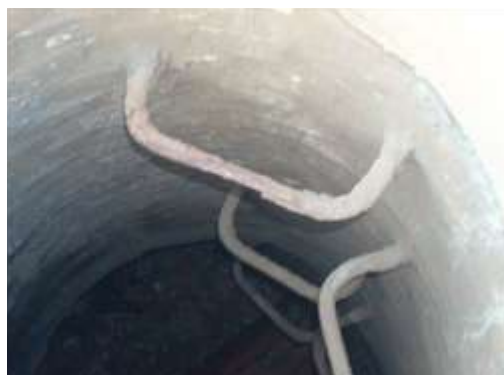
Defect 3

Steps Count: **6** Missing: **0** ☒ **Corroded**

CORRODED STEPS

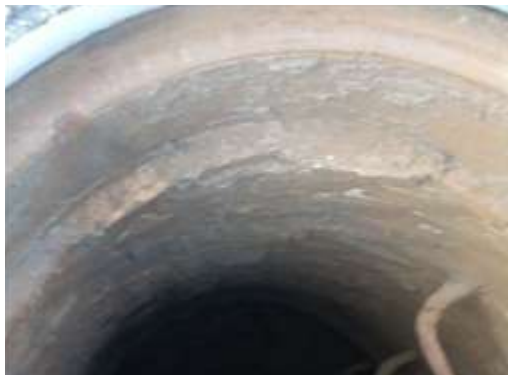
Defect 2

Frame Offset: **2** (in.) Condition: ☒ Sound ☐ Cracked ☐ Leaks

FRAME OFFSET

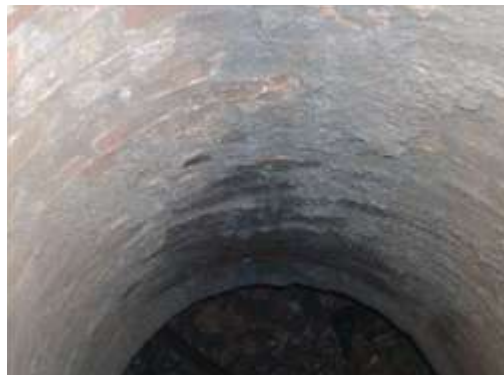
Defect 1

INFILTRATION EVIDENCE, CORBEL
WALL

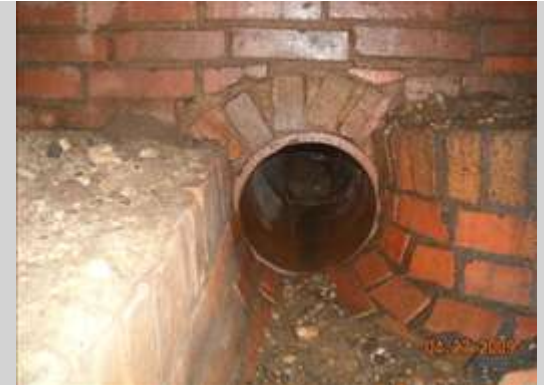
12 O'Clock Outflow

10 in. Circular Gravity Sewer
Pipe Out @ 12 O'Clock

Pipe Height: **9.6** (in.) Rod and Bar (Angled)
Pipe Material: **Clay** ☐ Pipe Lined
Invert Depth: **10.70** (ft.) Flow Characteristics: **None**
Deposits: ☒ None ☐ Mud ☐ Sludge ☐ Debris ☐ Grease
Silt Depth: (in.) Deposits Extent:
Infiltration: **None** Pipe Seal Cond: **Sound**

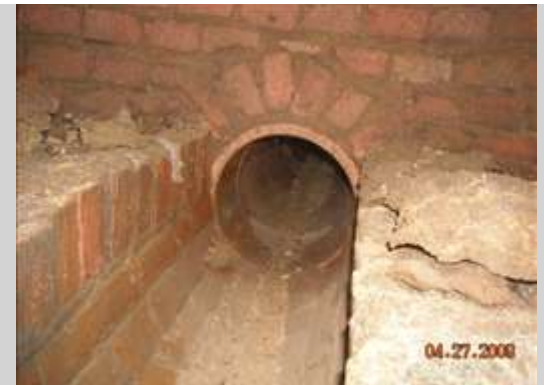
3 O'Clock Inflow

10 in. Circular Gravity Sewer
Pipe In @ 3 O'Clock

Pipe Height: **9.6** (in.) Rod and Bar (Angled)
Pipe Material: **Clay** ☐ Pipe Lined
Invert Depth: **10.05** (ft.) Flow Characteristics: **None**
Deposits: ☒ None ☐ Mud ☐ Sludge ☐ Debris ☐ Grease
Silt Depth: (in.) Deposits Extent:
Infiltration: **None** Pipe Seal Cond: **Sound**

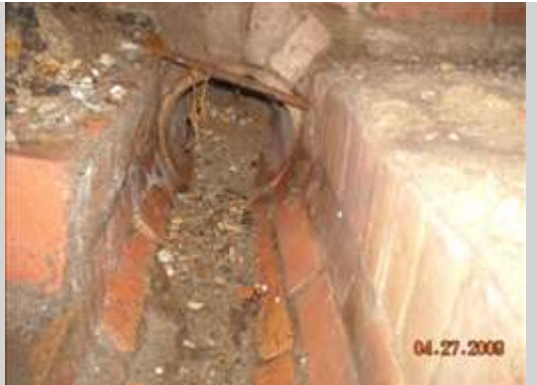
6 O'Clock Inflow

8 in. Circular Gravity Sewer
Pipe In @ 6 O'Clock

Pipe Height: **7.2** (in.) Rod and Bar (Angled)

Pipe Seal Cond: **Sound**
